DYNAMIC SCIENCE, INC.
In-Depth Accident Investigation

Contract DTNH22-94-D-27058
Case DSI-94-AB-022

TECHNICAL SUMMARY

CONTRACTOR: Dynamic Science, Inc.
CONTRACT NUMBER: DTNH22-94-D-27058
CASE NUMBER: Case DSI-94-AB-022

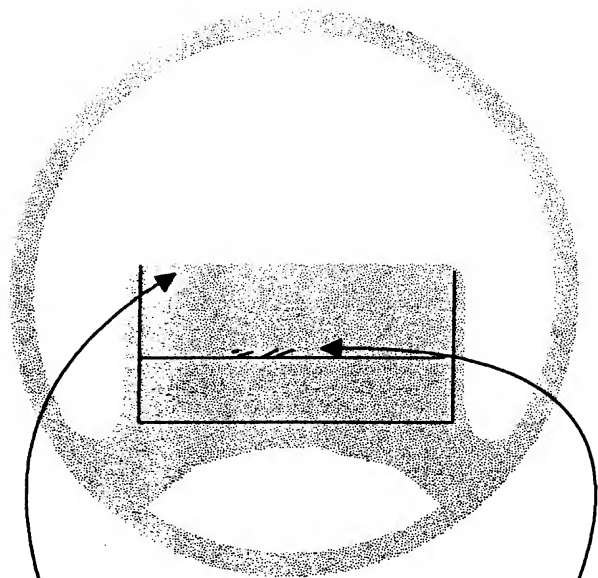
module cover torn away

Cloth transfers

upper torso, with the resulting back pressure cracking both the inner (hard plastic) and outer (soft plastic) covers. There is evidence (a clothing transfer) that indicates the driver came into contact with the exterior of the module cover. The concussive force of the deployment was primarily to the left side of the driver's upper body causing a laceration of the heart and the ascending aorta.

The steering column was displaced approximately 3.8 cm (1.5 in.) forward with complete shear capsule separation as a result of the driver's proximity to the module cover during the initiation of the airbag deployment sequence. The airbag contacted the driver's lips during deployment as noted by the red lipstick transfer on the left upper quadrant of the airbag. There were also abrasions to the left side of the driver's face from contact with the expanding airbag.

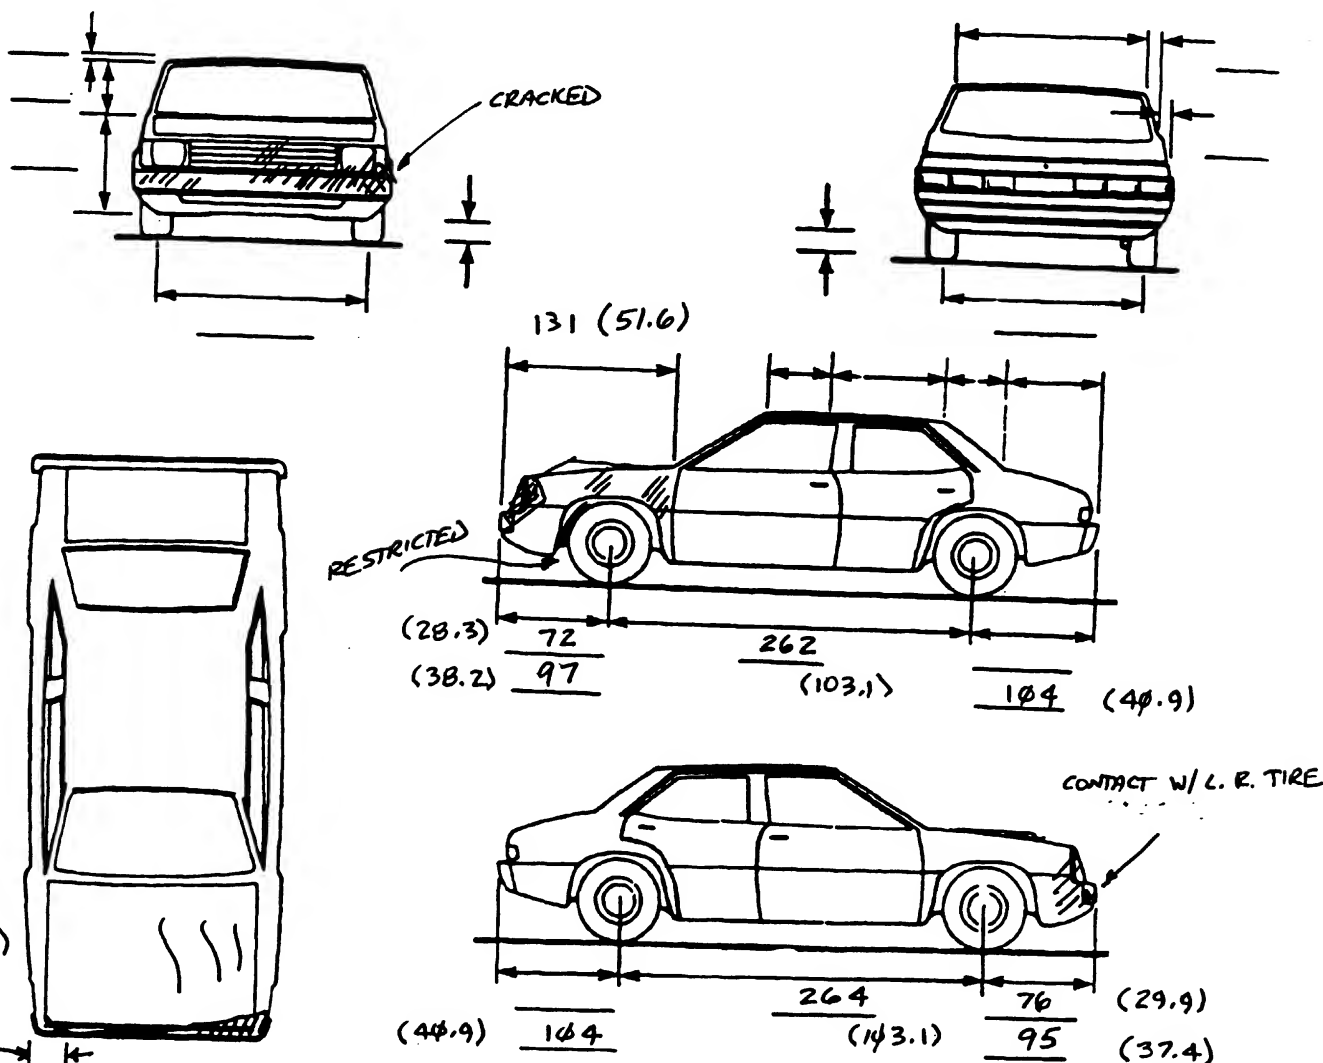
VEHICLE DAMAGE SKETCH

Specific Impact No.	Location of Direct Damage	Location of Field L
1	LF BUMPER CORNER

Specific Impact Number	Plane of Impact C-Measurements	Direct Damage		Field L	C ₁	C ₂	C ₃	C ₄	C ₅	C ₆	± D
		Width (CDC)	Max Crush								
1	BUMPER	52.7	9.6	51.5	9.6	5.1	3.1	2.4	2.75	5.3	
	- FREE SPACE		-4.φ		-4.φ	-1.75	-1.2	-1.2	-1.75	-4.φ	
			5.6		5.6	3.35	2.9	2.2	1.φ	1.3	φ
1	BUMPER	134	14	131	14	9	7	φ	3	3	φ

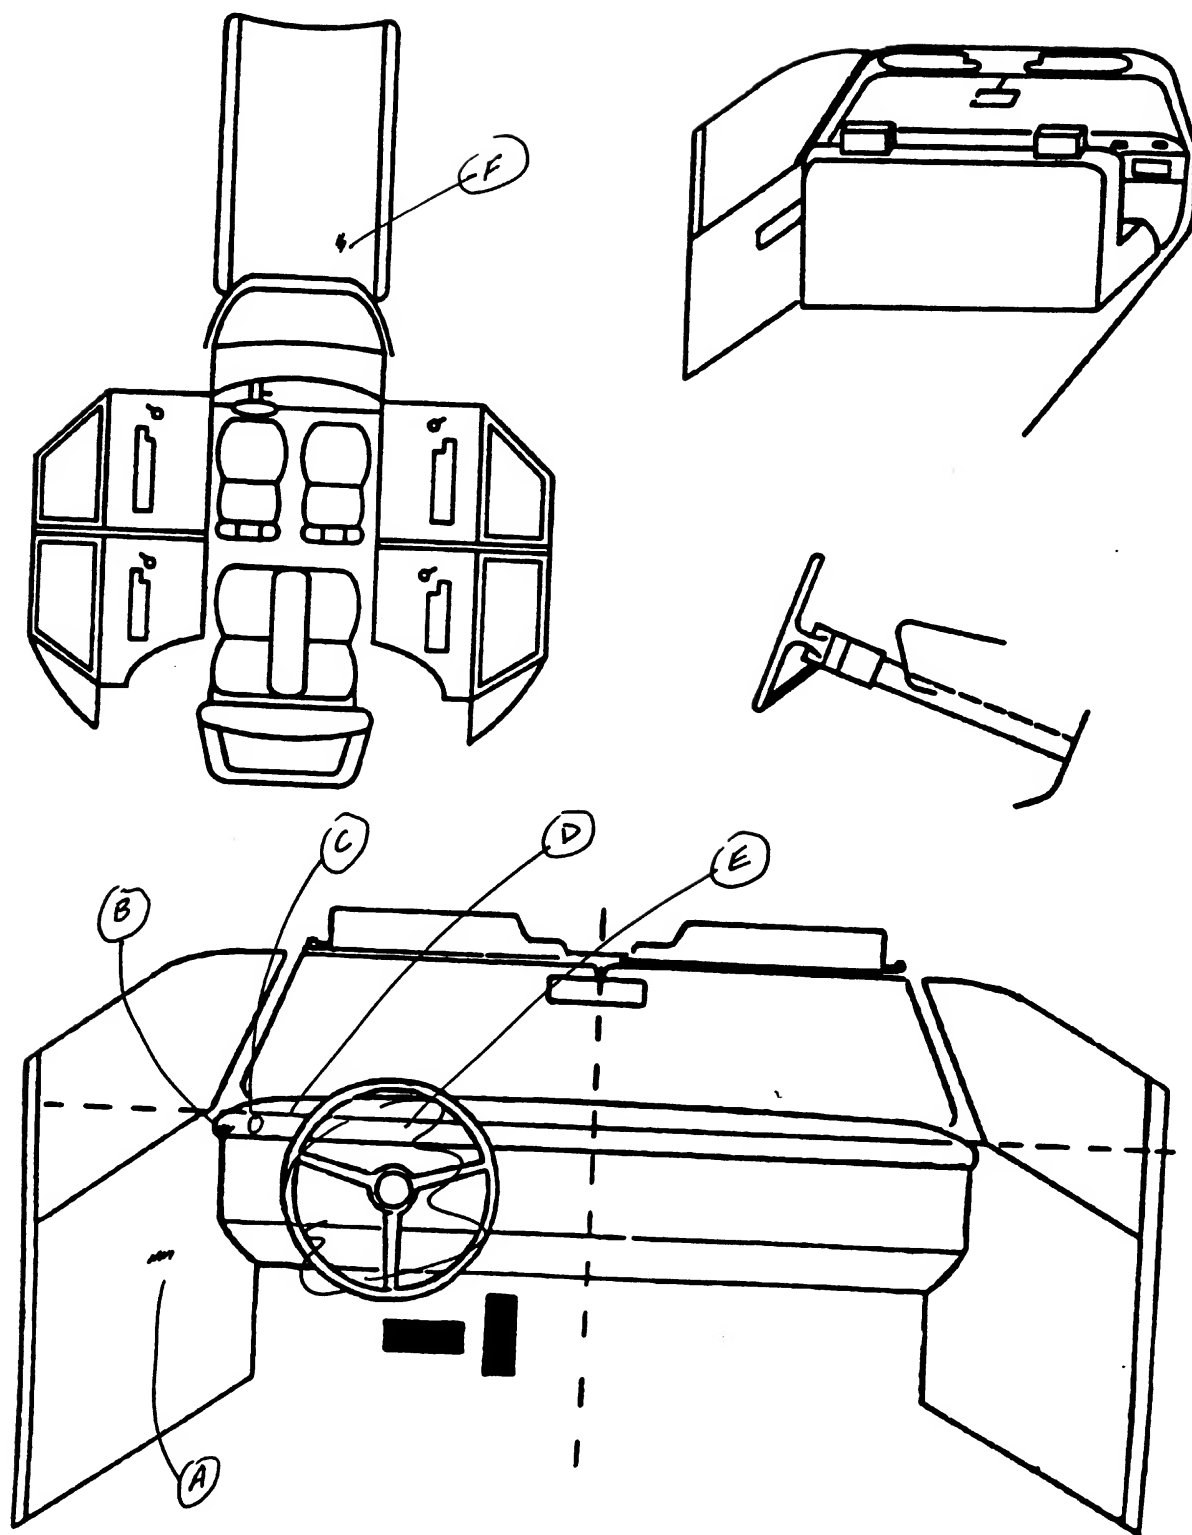
VEHICLE INTERIOR SKETCHES

Contact	Interior Component Contacted	Occupant No. If Known	Body Region If Known	Supporting Physical Evidence	Confidence Level of Contact Point
A	21	01	-	SCUFF	3
B	09	01	L. HAND?	SCUFF	3
C	09	01	L. HAND?	SWITCH OFF	3
D	09	01	-	SPEEDOMETER CRACKED/ENTIRE PANEL SHIFTED	2
E	45	01	FACE	LIPSTICK	1
F	54	01?	-	SMALL SCUFF	3
G					
H					
I					
J					
K					
L					
M					
N

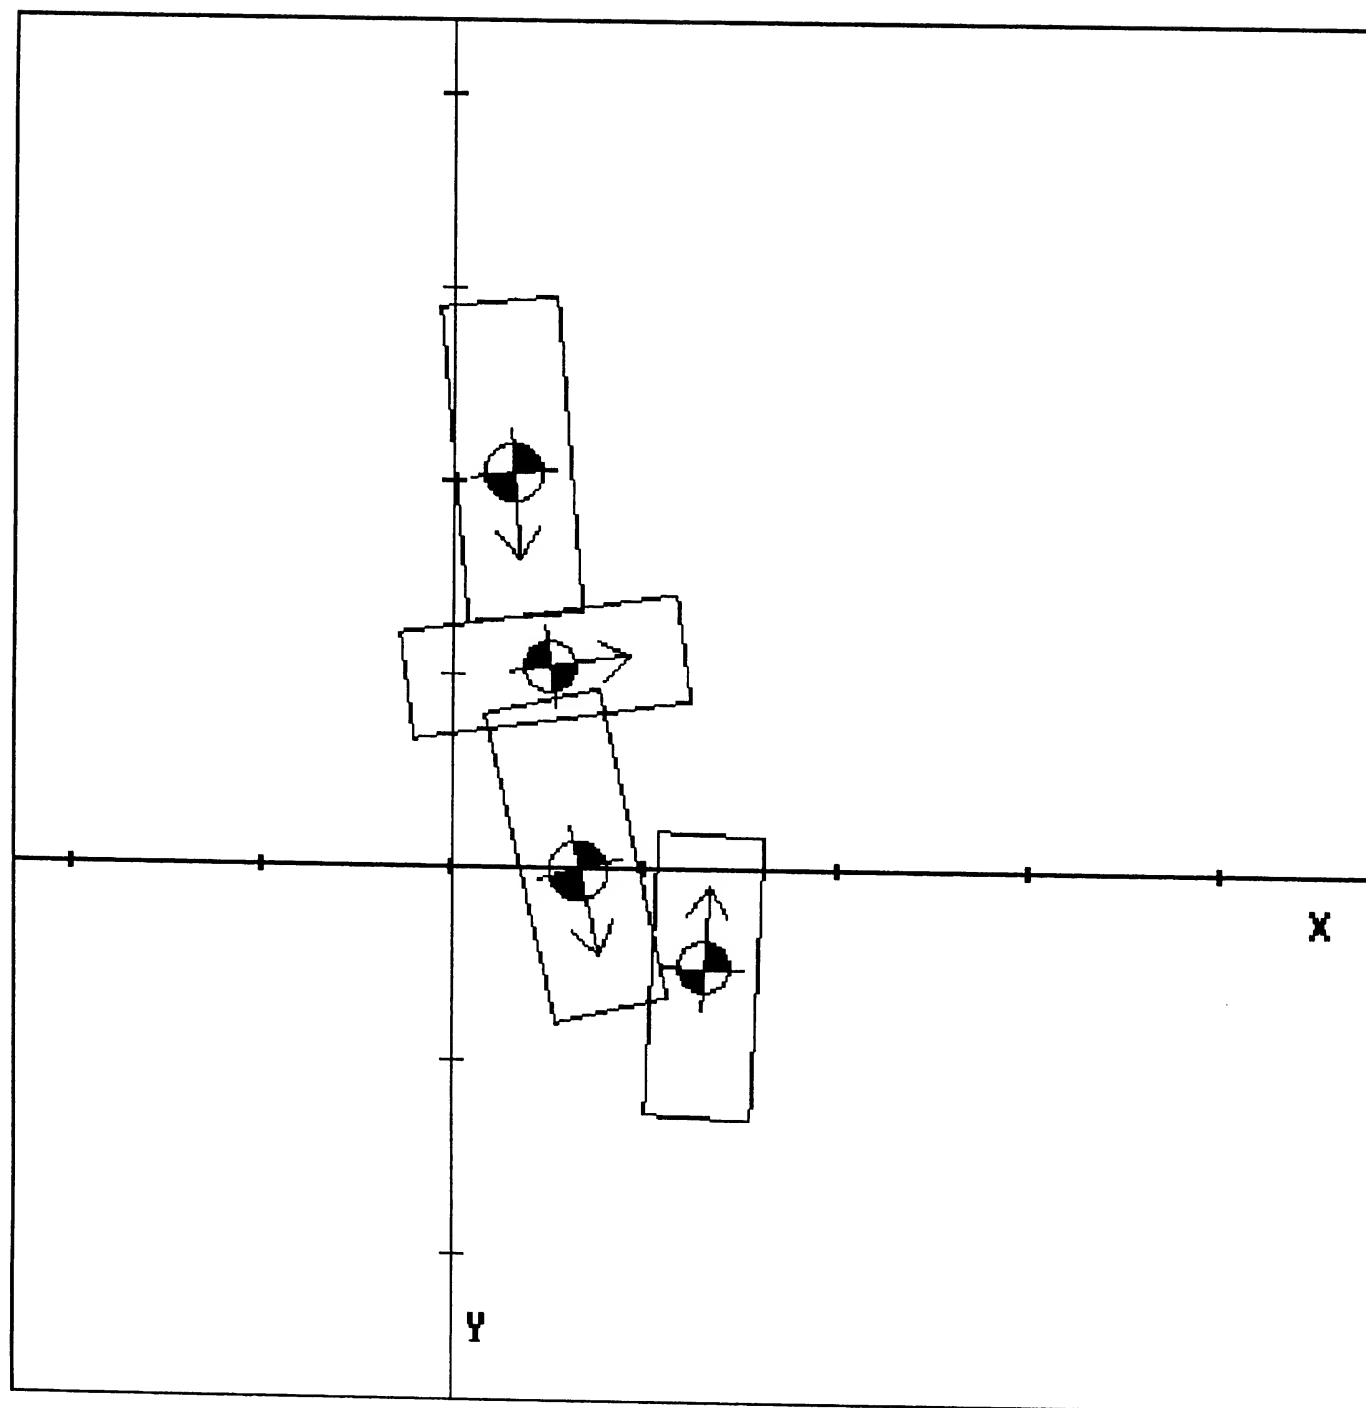
EDCRASH
Site Drawing

COEFFICIENT OF RESTITUTION (LINEAR MOMENTUM)

-0.058

Ueh #1	Ueh #2
Impact		
Speed	21.8	5.2
X	3.0	5.0
Y	-20.5	-10.5
Psi	85.0	-8.0
Rest		
X	6.5	13.0
Y	0.0	5.0
Psi	77.0	-87.0

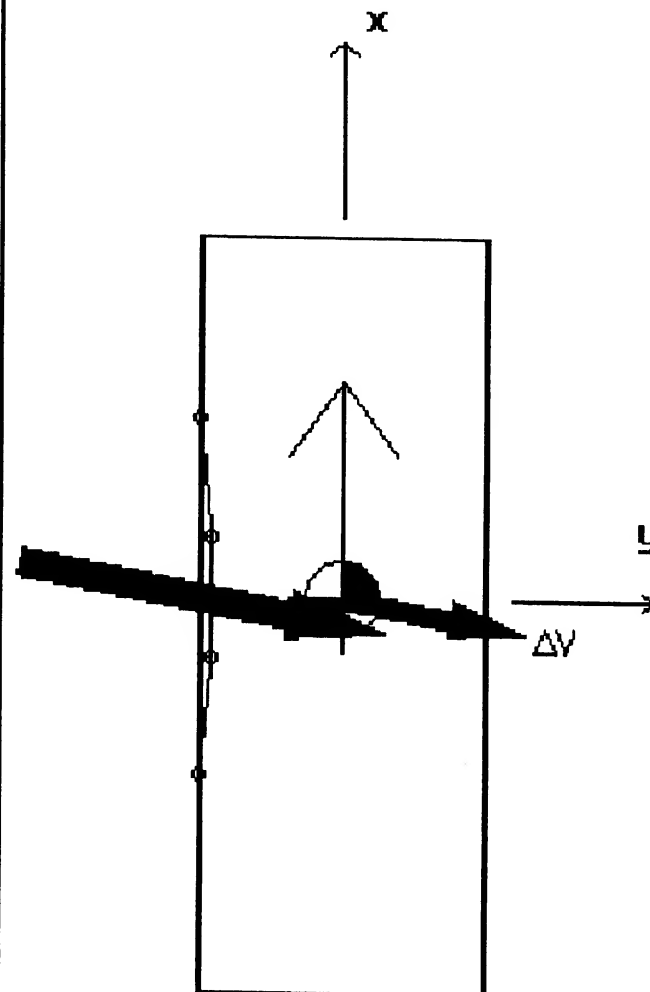
Vehicle No. 2

CDC/PDOF: 091pew1 -79.7 deg
Max Impact Force: 22251 lb

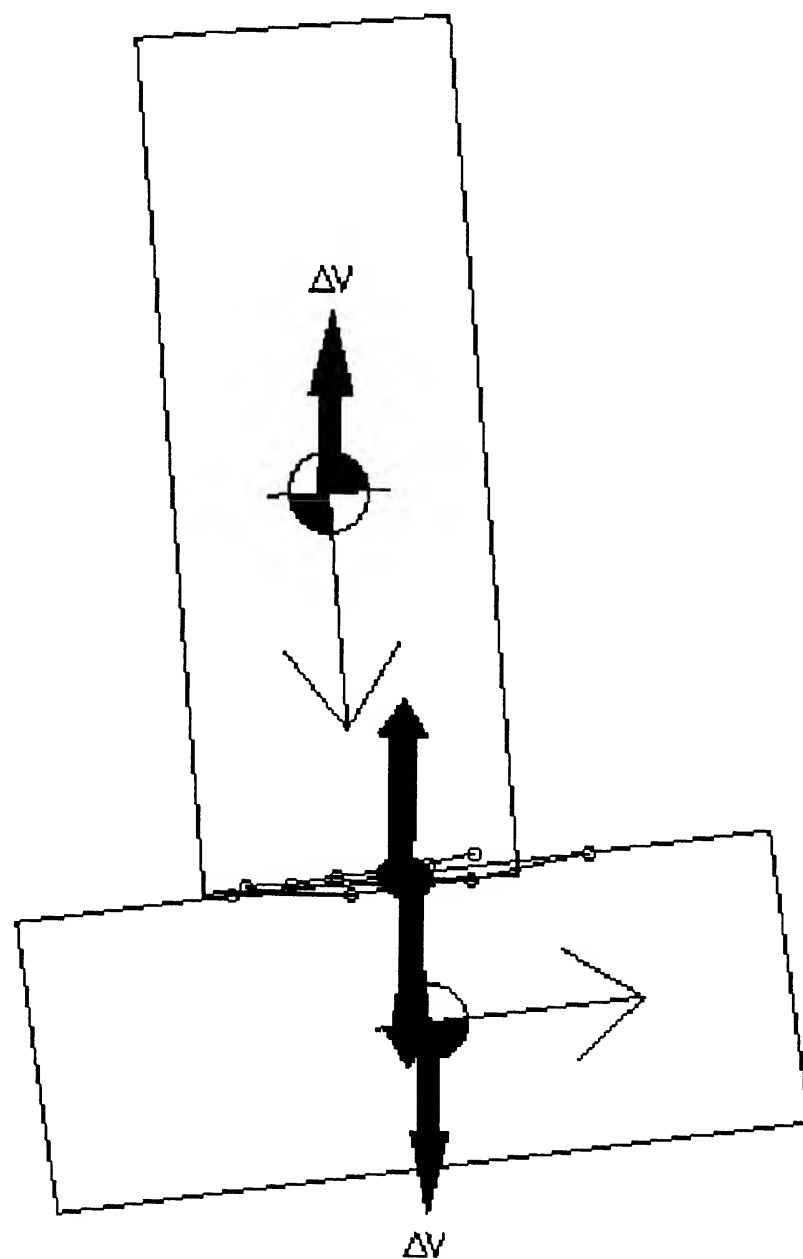
EDCRASH
At Impact

Veh #1	Veh #2
Delta-U (mph):		
X	-7.0	-1.3
Y	-0.9	7.2
Tot	7.0	7.3

Crush Data (in):		
W	53.0	83.0
D	0.0	0.0
C1	5.6	0.0
C2	3.4	2.8
C3	2.9	2.8
C4	2.2	0.0
C5	1.0	
C6	1.3

Ueh #1	Ueh #2
Velocities (mph)		
Tot	21.8	5.2
Fwd	21.8	5.2
Lat	0.0	0.0
Beta	0.0	0.0
